# FACILITY COMPLIANCE INSPECTION REPORT

**Date of Site Inspection:** July 9, 2014

Coble's Sandrock, Inc. C&D Landfill  
5833 Foster Store Road  
Liberty, NC 27298

Comprehensive Inspection

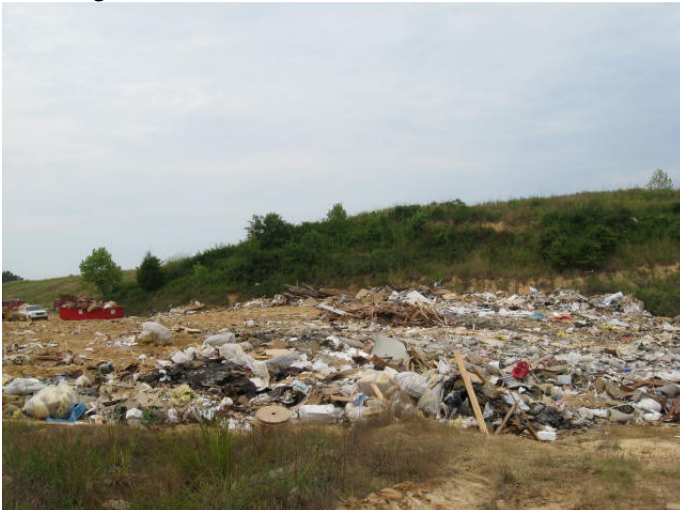
Working face, Phase 3A

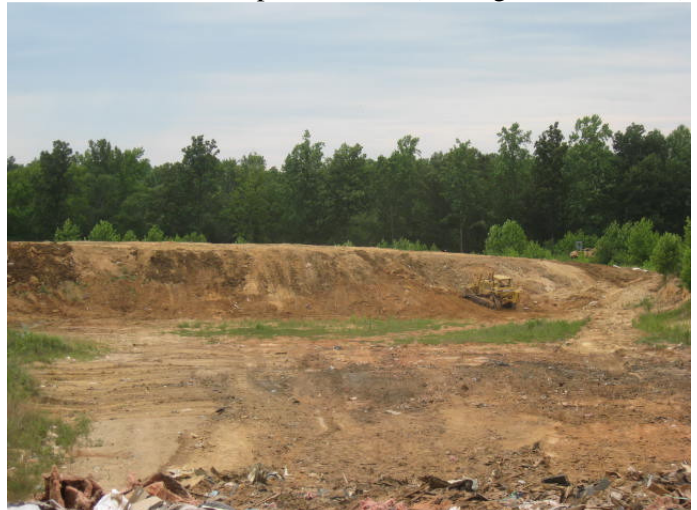
20. The facility shall cover solid waste with six-inches of soil when the waste disposal area exceeds one-half acre and at least once weekly.
21. Solid waste along the internal side slope of Phase 2A (leading into Phase 3A) required additional soil cover. During the inspection the facility covered and graded the side slope. Also, during the inspection, Solid waste located within a non-active area of Phase 3A was pushed into the working face.

Soil added to side slope Phase 2A (leading into Phase 3A)

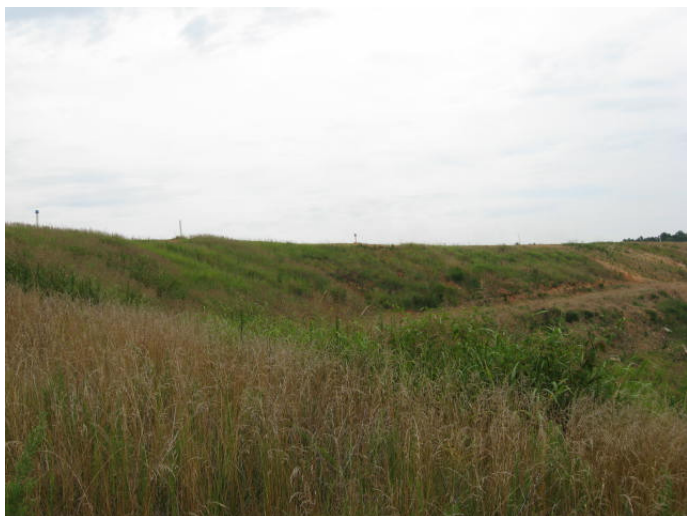
External side slope Phases 1A and 2B (west)

19. The landfill cap atop the final contoured phases appeared to contain adequate soil cover. Ensure erosion rills are repaired and additional grass seed sown.

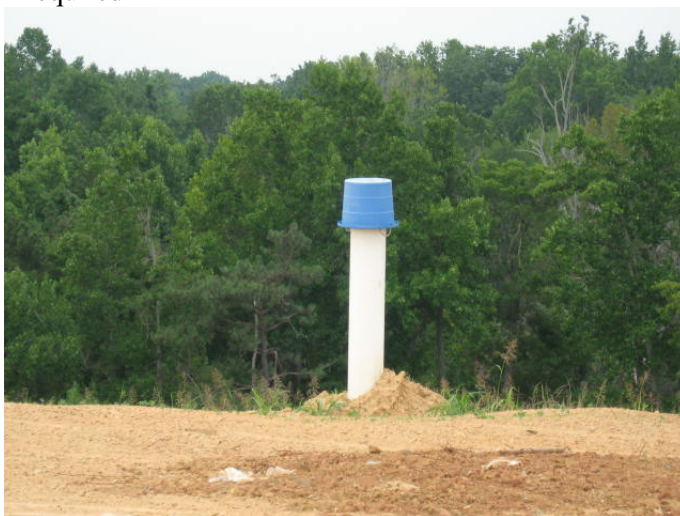
35. The facility has installed landfill gas (LFG) vents atop Phases 1A, 2A, and 2B.
36. Six of the landfill gas vents do not contain a 90° elbow but contain blue buckets – turned upside down. Two of the buckets have blown-off/are gone and the LFG vents are currently vertical open pipes. Contact Ervin Lane – Compliance Hydrogeologist (SWS) at 919-707-8288 regarding installation of appropriate LFG vent caps.

LFG vent with bucket atop (representative) – repair as required

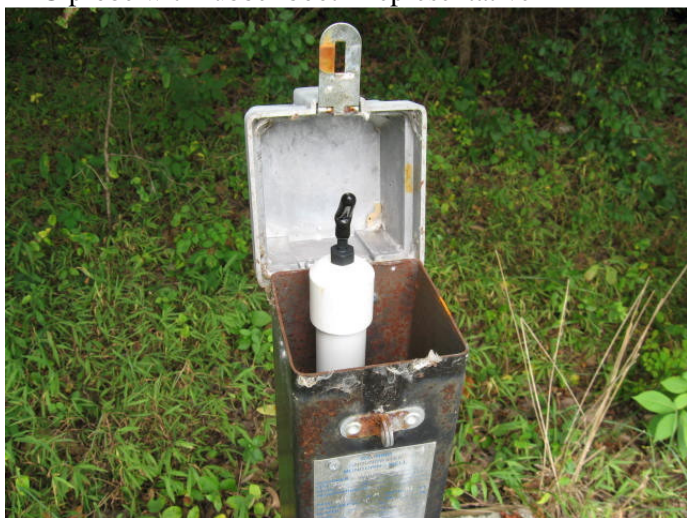
30. The following landfill gas probes were observed: GP-2, 3, and 4. Landfill gas probe GP-1 was not observed during the inspection.
31. The landfill gas probes observed contain a nipple with rubber boot atop. They do not contain stopcock valves or quick connect couplings. Contact Ervin Lane – Compliance Hydrogeologist (SWS) at 919-707-8288 to discuss proper landfill gas monitoring technique.

LFG probe with rubber boot – representative

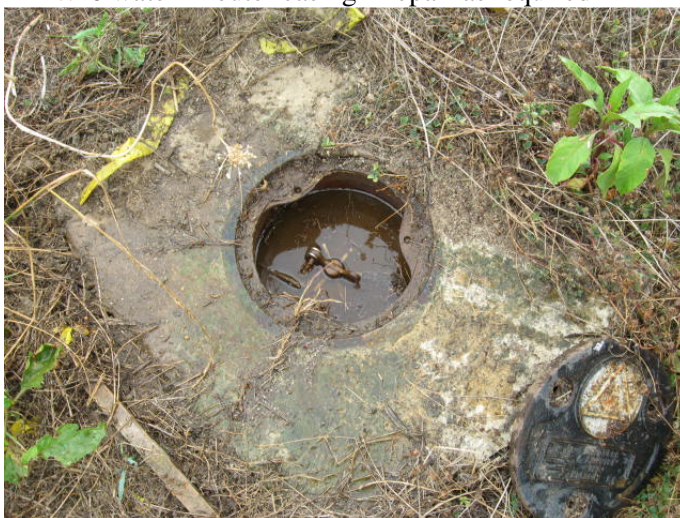
28. Groundwater monitoring well MW-6 is below grade (surface water infiltration into outer casing) and did not appear to contain a well tag. Groundwater monitoring well MW-10S has a large crack in the concrete slab. Groundwater monitoring well 19S (labeled: P19S) was converted from a piezometer to groundwater well. Contact Ervin Lane – Compliance Hydrogeologist (SWS) at 919-707-8288 regarding groundwater monitoring wells MW-6 and MW-10S.

MW-6 water in outer casing – repair as required

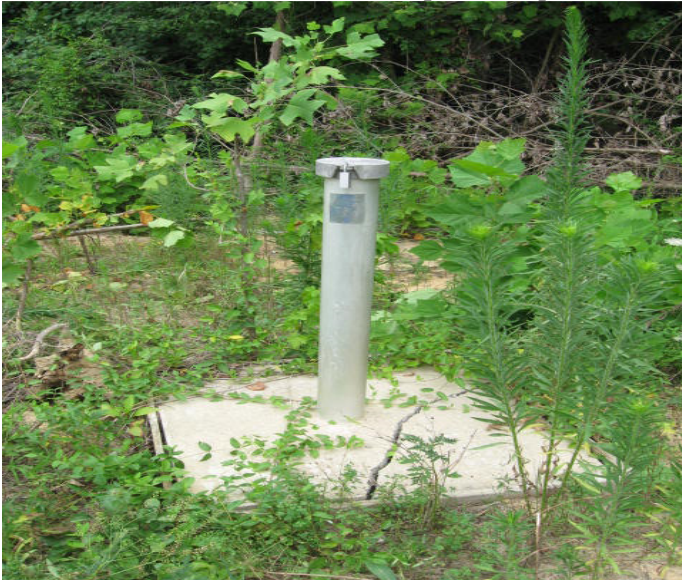
MW-10S cracked concrete slab – repair as required

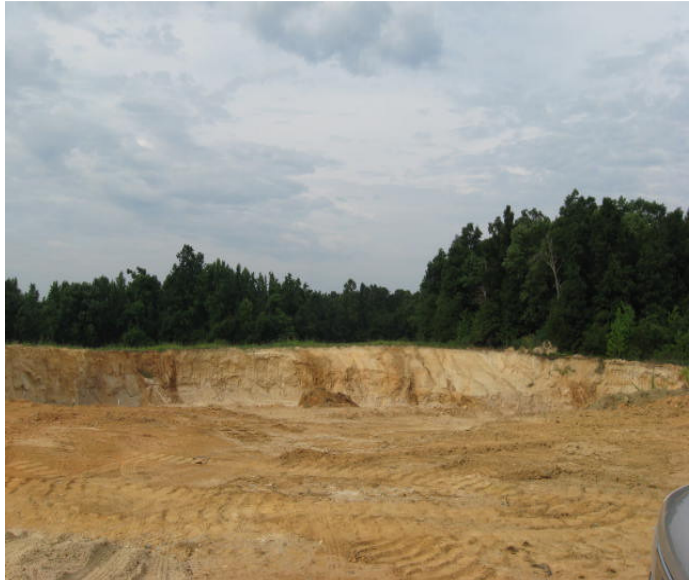
37. The facility obtains soil from a borrow area in proposed Phase 7 and when available from off site.
38. The Snow Camp Volunteer Fire Department and/or the E.M. Holt Fire Department will address an emergency at the facility.
39. No windblown material was observed.
40. The facility has all-weather access roads.
41. The facility is secured by a locked gate.
42. The facility has proper signage.
43. The facility permit renewal application is currently under review.

Soil borrow area

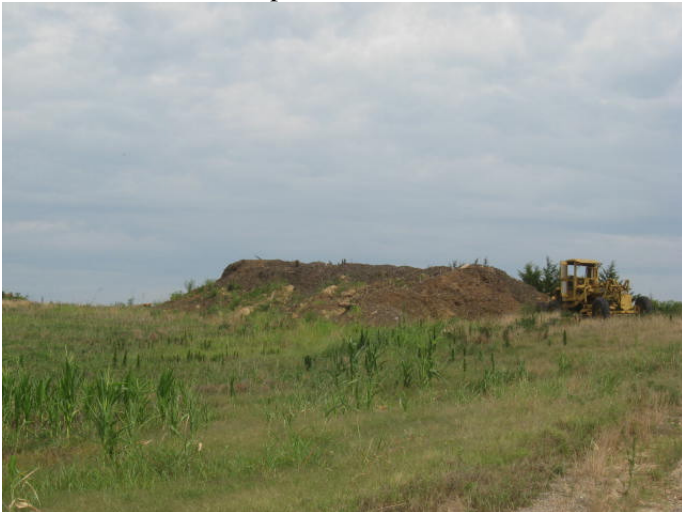
Soil mixed with wood pile – to be screened

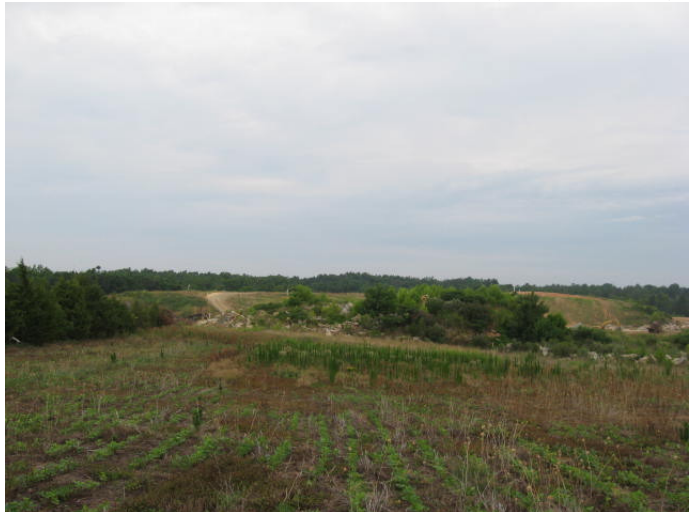
1. The facility has a conditionally approved temporary disaster debris staging site (TDDSS) at the landfill for C&D and vegetative debris.
2. The TDDSS number is: DS01-015.
3. Three acres are allotted for the management of vegetative debris within the undeveloped landfill future Phase 5.
4. The C&D will be placed in the landfill, managed according to facility permit, operations plan, and SWS rules.
5. The vegetative debris will be ground and removed for boiler fuel and/or sold as mulch.
6. The facility has submitted standard operating procedure (SOP) for the management of C&D and vegetative debris associated with a disaster/storm event.

View toward 3 acres allotted for TDDSS (future Phase 5)

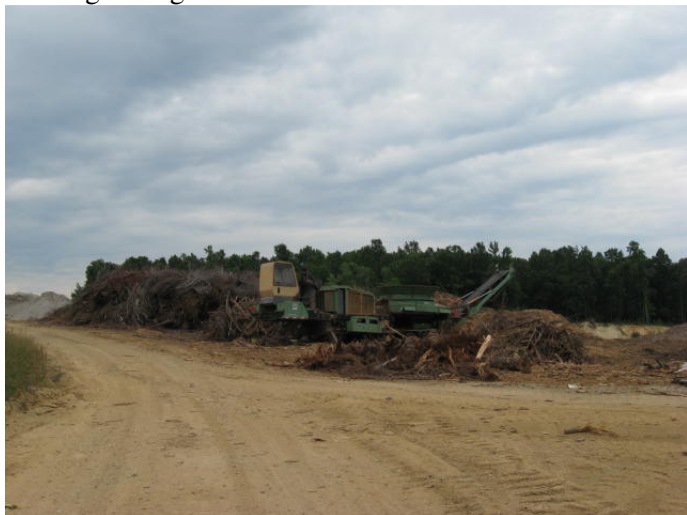
5. The facility stores scrap metal in roll-off containers.
6. The facility has a stockpile of vegetative and clean wood stored on site. Records state that there is 7,200 yd<sup>3</sup> of wood on site. Ensure only high carbon nitrogen ratio material is ground. Kent Coble stated that the wood should be ground within two months. Wood mulch is sold for boiler fuel.

Wood grinding area

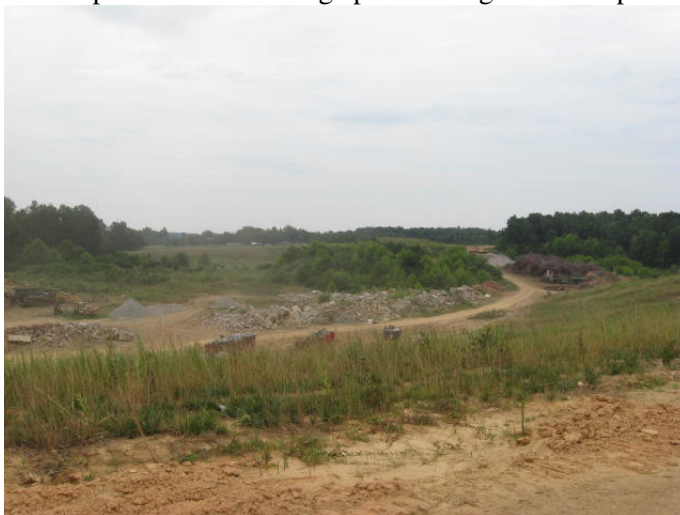
8. The facility has a large stockpile of concrete on site (in future Phases 4 and 5, large pile of concrete has vegetation atop). Kent Coble stated that he plans to crush concrete every few months. The amount of concrete on site is unknown.

Stockpiled concrete – large pile has vegetation atop

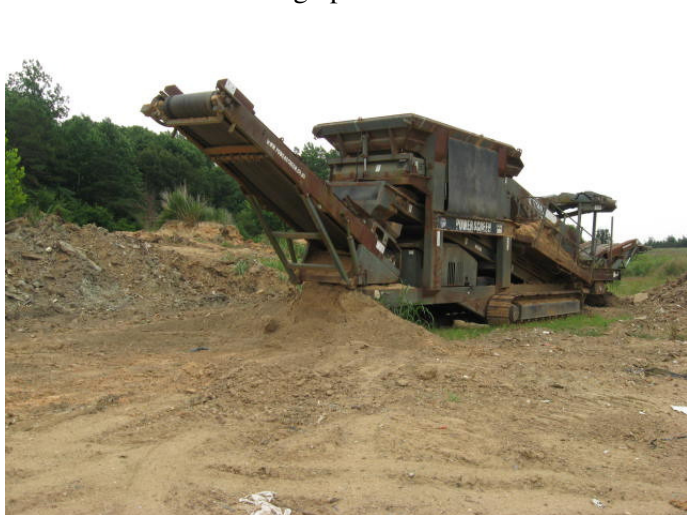
9. The facility operations plan states that an old land clearing and inert debris (LCID) landfill on site (in future Phase 4) is mined. The screened soil will be used as a soil amendment for cover material. Kent Coble stated that ~ half the old LCID landfill has been mined.
10. The facility has a pile of soil mixed with wood stored on site. Kent Coble stated that the soil wood mix will be screened.
11. Brenda Coble stated that the facility may want to recover sheetrock and grind it for reuse as an agricultural product/for sale.
12. The facility does not conduct a compost operation on site.
13. There is a notified LCID landfill (ID No. N0144) located on the property, adjacent to the C&D landfill. The notified LCID landfill is not currently located within future phases of the C&D landfill.
14. Ensure an adequate fire lane is maintained amidst the recycled materials recovery activities.

Old LCID landfill mining operation soil screener

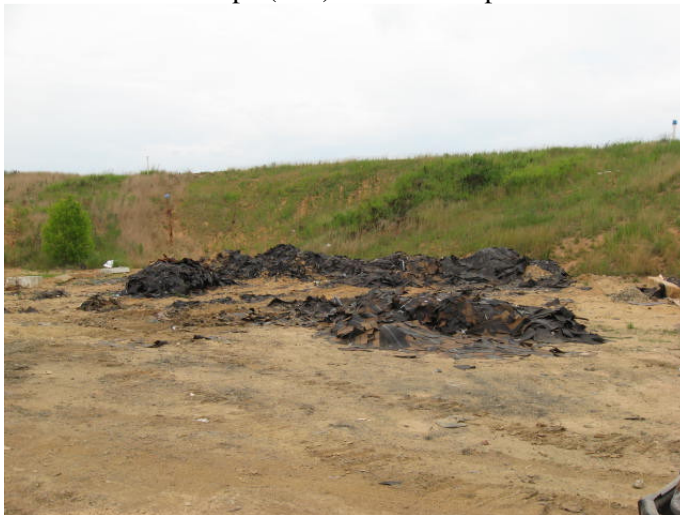
3. The PRAS operation is located at the toe of the east side slope of Phase 2B.
4. The approved area allotted for the PRAS operation is 100' x 100'.
5. The location of the PRAS operation will migrate as the landfill expands into future phases.

Phase 2B side slope (east) and PRAS operation
